ENGINEERING REPORT

**MONTGOMERY DAM
HYDROLOGIC & HYDRAULIC EVALUATION &
DAM EMBANKMENT STABILITY ANALYSIS**

**PIKE TOWNSHIP
CLEARFIELD COUNTY, PENNSYLVANIA**

MAY 2008

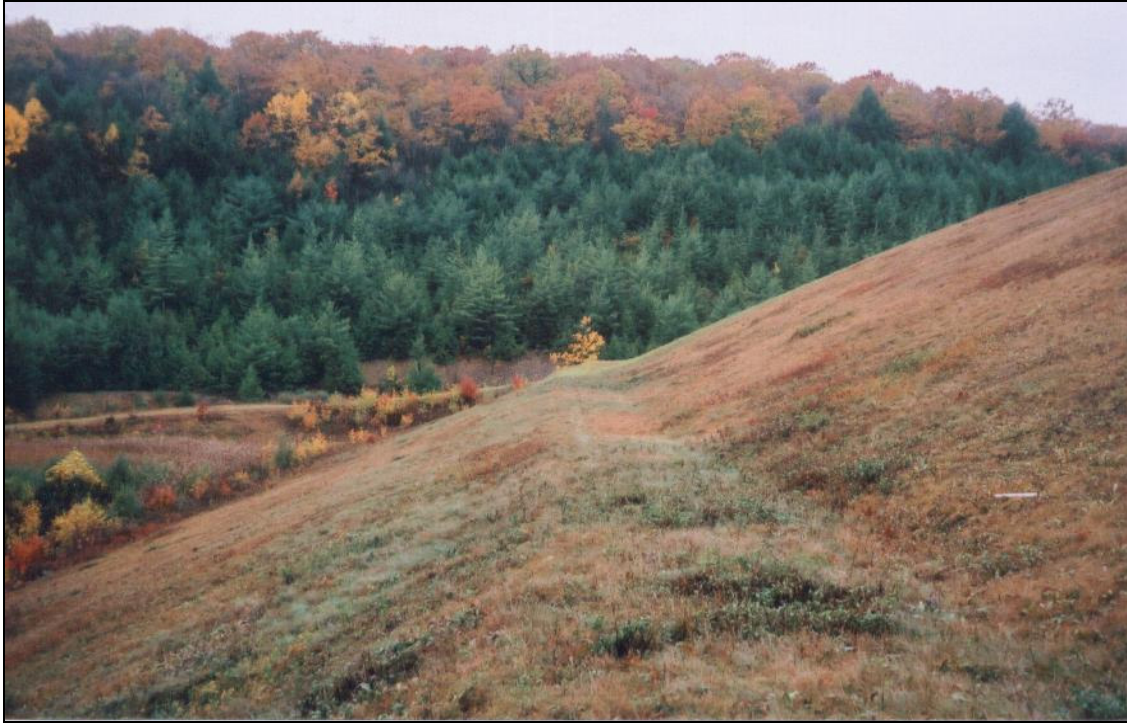
Figure 1: Bench #2 Added for Embankment Stability

Based on the evaluation of the embankment, two new berms were added to the downstream face to add weight to the dam and improve stability of the embankment (refer to Figure No. 1 & 2). A new toe drain was installed and gabion baskets were installed at the left end of the spillway wall to control seepage. Four (4) of the piezometers remain on Montgomery Dam for daily monitoring purposes.

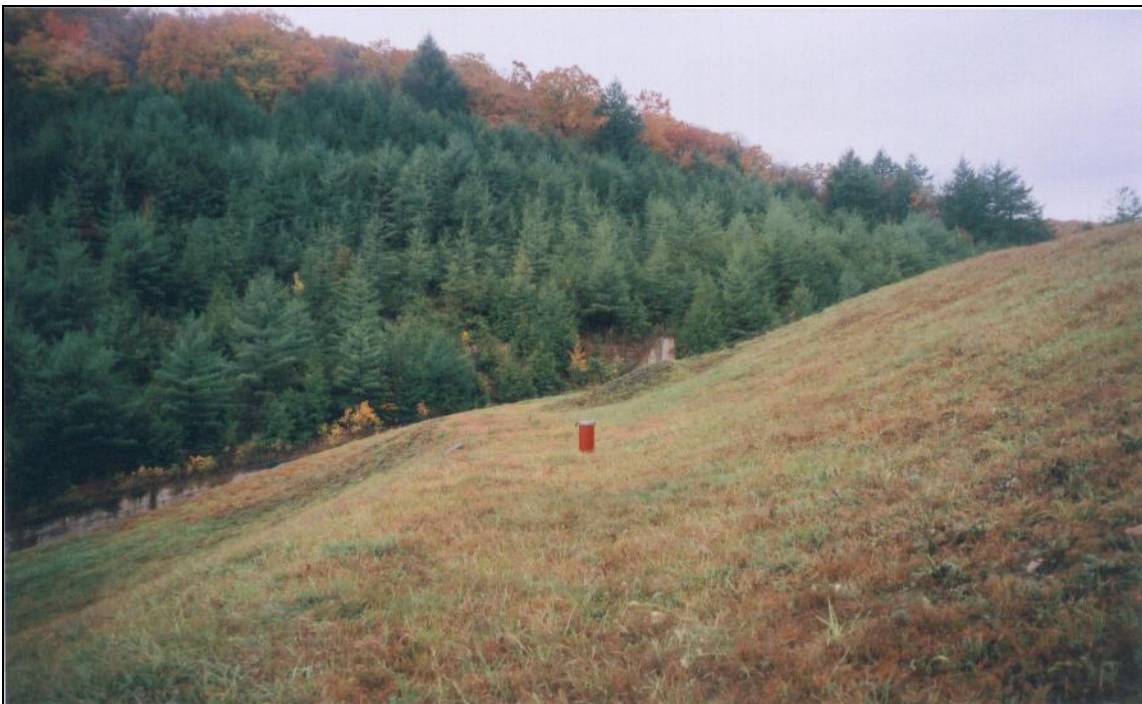
Figure 2: Piezometer Along Bench #1

As a result of the Phase I inspection report, Hill & Hill Engineering, Inc. installed 17 piezometers in Montgomery Dam to monitor seepage through the dam and to evaluate the stability of the embankment. Core borings were taken along the embankment. Lincoln DeVore Testing Laboratory, Inc. was hired to perform a stability analysis of the embankment. The stability analysis revealed that the existing embankment was not stable for high flow conditions.

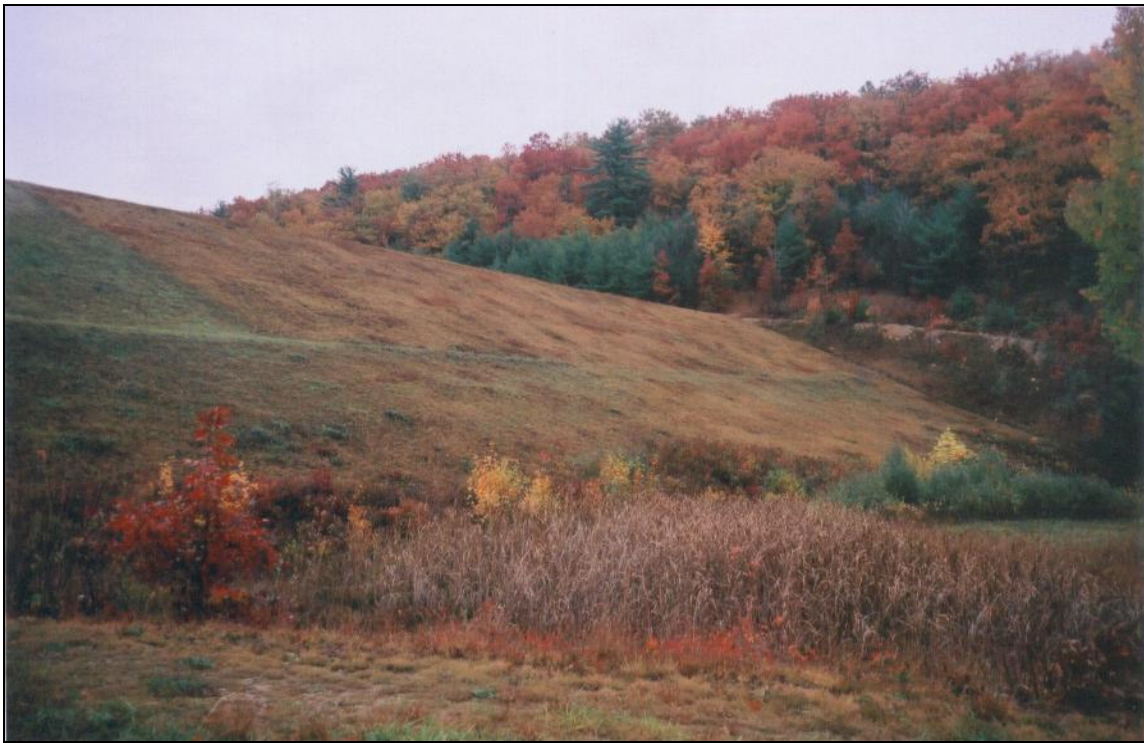
Figure 3: Overall Downstream View of Dam

The dam and its appurtenances were considered to be in good condition at the time of the 2007 inspection (refer to Figure No. 3). Seepage at the toe of the dam, noted in previous inspection reports, is being monitored by three (3) 90° V-notch weirs. These weirs were installed in 1991 by the Owner. The flow measurements at all three (3) weirs show a fairly constant flow throughout the year (refer to Figure No. 4). There were no signs of turbidity from this seepage at the time of inspection, nor has the Authority observed any signs of turbidity throughout the year. The Authority reports that accumulated sediment behind the weirs is cleaned out two days prior to weir readings.

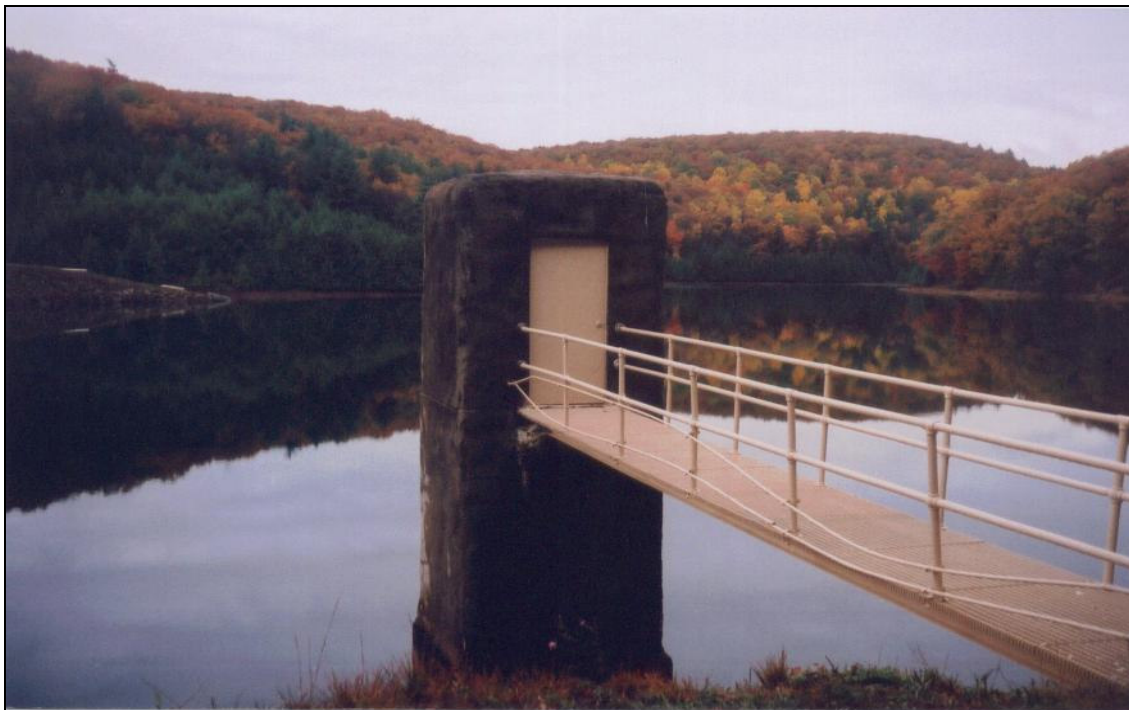
Figure 5: Exterior of Intake Tower Structure above Reservoir Level

The concrete intake structure above the normal pool level was rehabilitated via shotcrete (pressure mortar surfacing) application in 1995. The structure is in good condition (Refer to Figure No. 5).

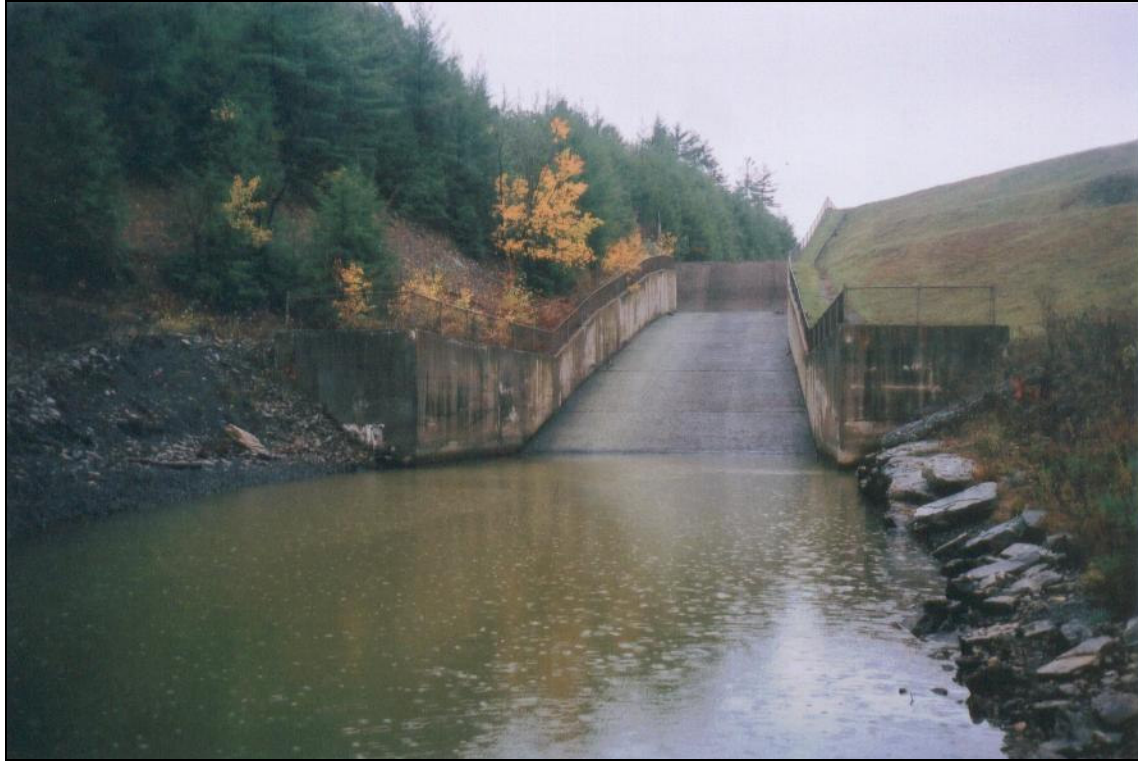
Figure 6: Spillway Chute, Looking Upstream

During previous inspections, the reinforced concrete spillway walls have shown signs of efflorescence and deterioration. The Authority repaired concrete deterioration via shotcrete application. However, during this inspection and due to the low water level, spalling was observed on the upstream approach channel corner and downstream right spillway wingwall. Efflorescence was also noted along the left spillway wall and downstream right corner. This condition should be monitored in subsequent years for any changes (refer to Figure No. 6 & 7).

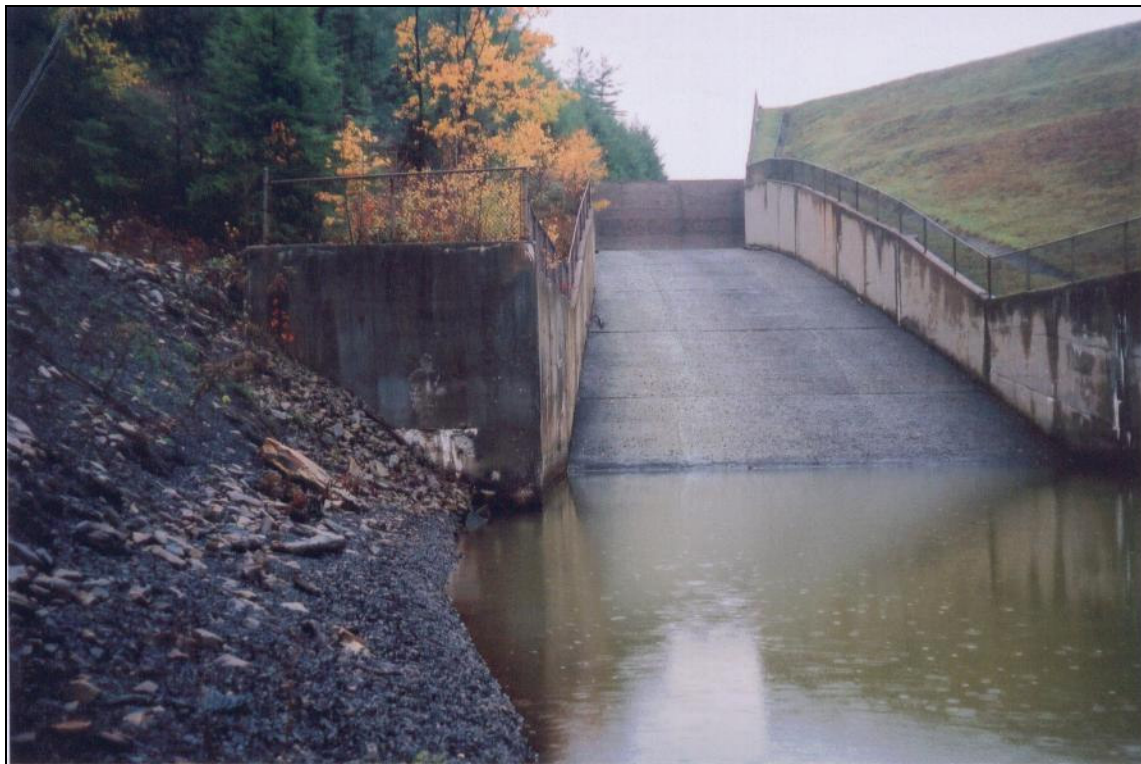
Figure 7: Spillway Discharge Basin

The stilling basin slopes have shown minor surface erosion since the 2004 inspection. Additionally, the stilling basin left slope has shown undermining at the gabion baskets. It was recommended that the Authority should take steps to prevent this surface erosion and undermining.
