ENGINEERING REPORT

**MONTGOMERY DAM
HYDROLOGIC & HYDRAULIC EVALUATION &
DAM EMBANKMENT STABILITY ANALYSIS**

**PIKE TOWNSHIP
CLEARFIELD COUNTY, PENNSYLVANIA**

MAY 2008

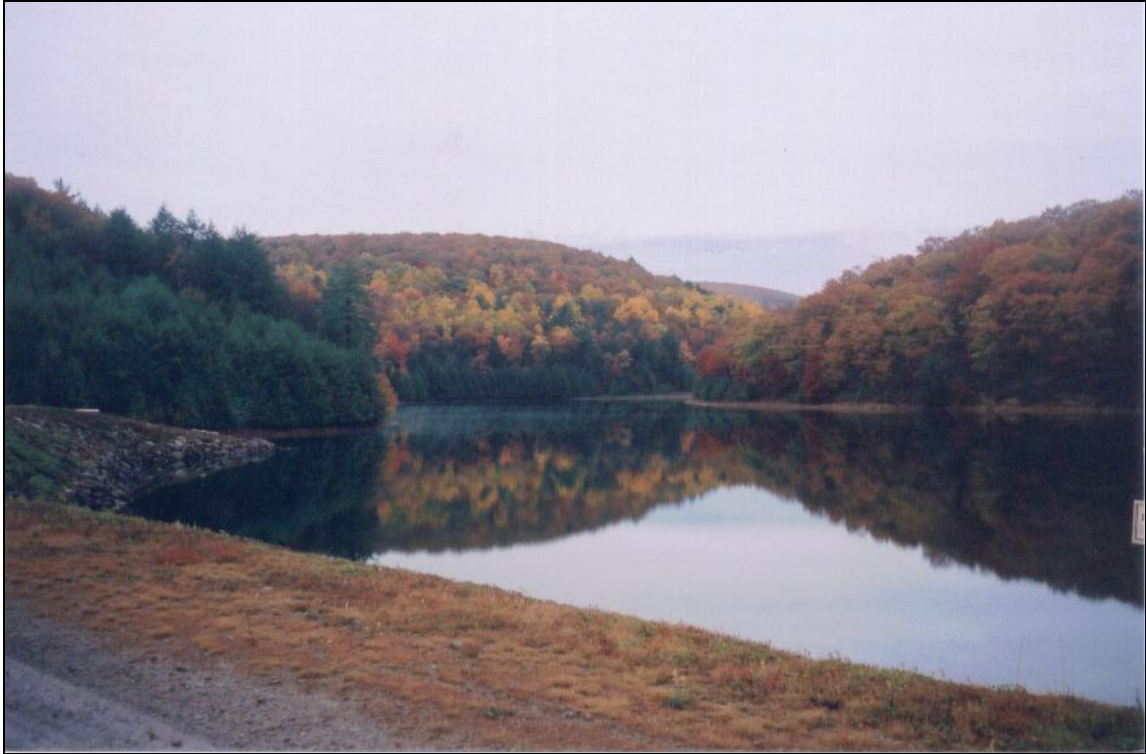
Figure 8: Reservoir Area

Size Classification is determined by either the impoundment storage or height, whichever provides the higher classification. Montgomery Dam has a height of 71 feet and a total capacity of 1,250 acre-feet (407 million gallons) (Refer to Figure No. 8). The top of dam elevation (Elev. 1411) was used to determine the total storage volume of the reservoir. Montgomery Dam would be classified as Class “B” by the PADEP or as “Intermediate” by the U.S. Army Corps of Engineers.

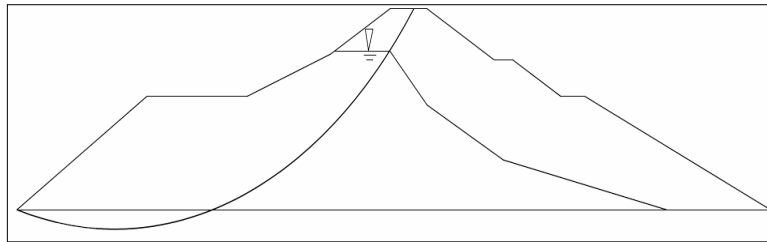
Figure 12: Typical Stability/Embankment Profile

The existing downstream slope was analyzed for stability against headwater pressure for two cases; with and without a floodwall. The factor of safety for the headwater pressure without the floodwall was 5.66 and with a 5-foot floodwall was 3.07. The factor of safety for horizontal shear in the downstream portion of the dam is 2.2. The safety factors are well above the typical factor of safety of 1.5 for both of the stability conditions analyzed. A "dangerous circle" analysis of the downstream embankment yielded a minimum factor of safety of 1.31, which is less than the typical factor of safety for new embankments. However, based on the past performance of the existing embankment, modifications to the downstream slope are not recommended. The existing downstream slopes of 2H:1V and 2.5H:1V are acceptable.

The existing upstream slope of the reservoir was analyzed for horizontal shear, which checks for safety against sudden or rapid drawdown. A factor of safety of 1.29 was calculated, which is an acceptable factor of safety according to U.S. Army Corps of Engineers guidelines which use a factor of safety of 1.1 for this condition. A "dangerous circle" analysis of the upstream embankment yielded a factor of safety of 0.90. The soil properties used were conservative, which may help to explain the low factor of safety. It is unlikely that the soil is cohesionless, based on previous soils data. The factor of safety is greater than 1.0 even if a small cohesion factor of 0.10 is used in the stability calculations.

It may be necessary to perform a geotechnical investigation during the design phase of this project to verify the embankment stability under rapid drawdown and "dangerous circle" conditions.
